# **Surface-Tolerant Coatings for Aircraft Hangars, Flight Control Tower, and Deluge Tanks at Fort Campbell**

Final Report on Project AR-F-320 for FY05

June 2007

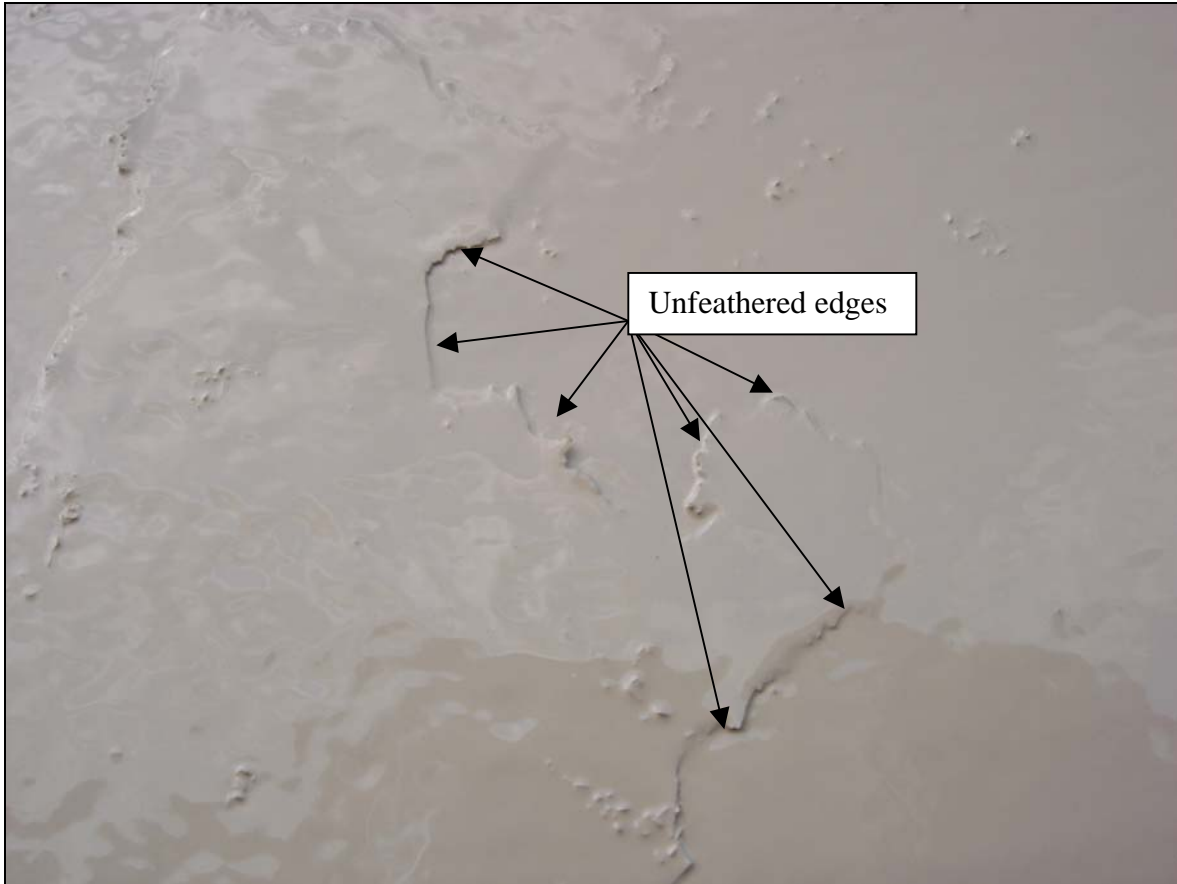
**Figure 2: Unfeathered areas on Destiny Tank**

MANTA's Statement of Work did not require feathering; however, some of these unfeathered areas are already showing initial indications of lifting. Coatings tend to pull away from these jagged edges during the curing process, leaving them exposed. Over time as the tank surface is exposed to thermal gradients, it will contract and expand. It is likely that additional degradation and / or lifting will occur in some of these unfeathered areas over time. It is advisable to inspect these areas on a periodic basis so that minor repairs can be affected if necessary.

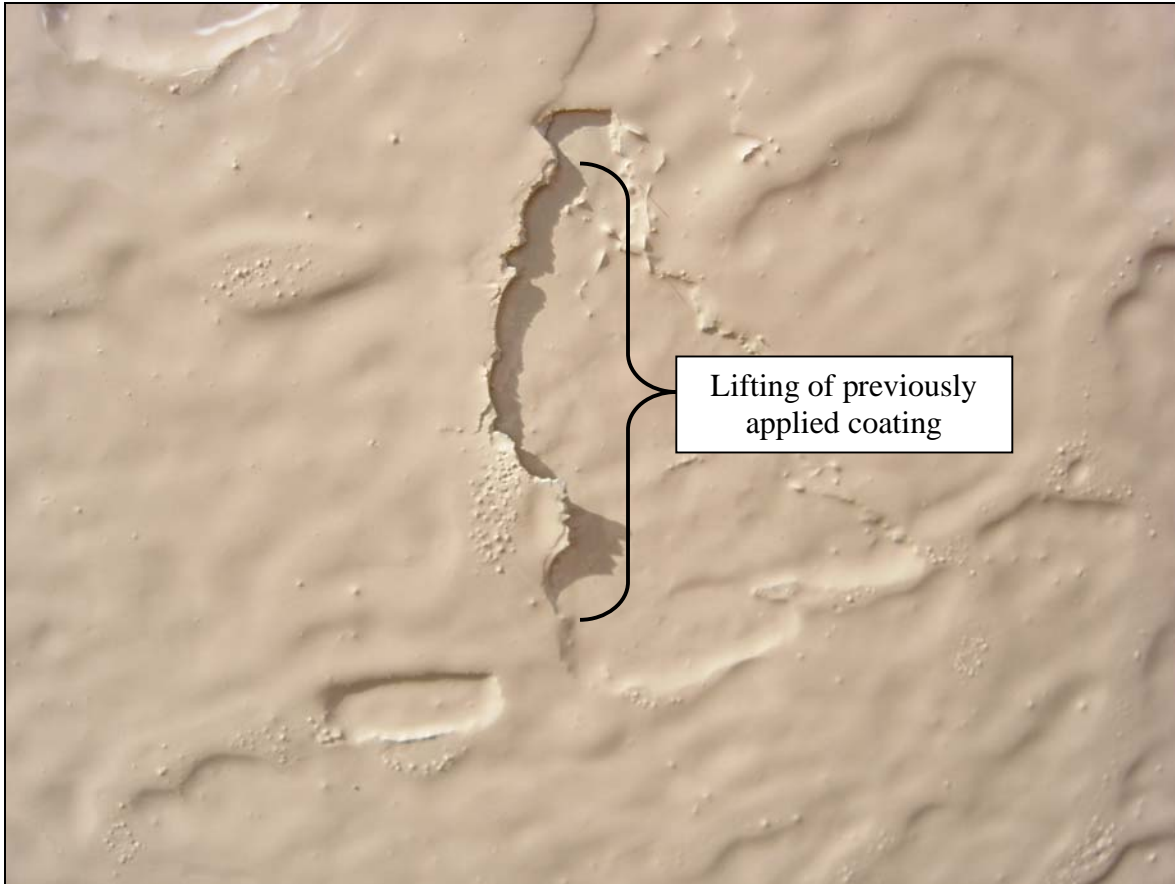
If the lifting is a result of curling, it will occur in the areas where the solvent sensitive coating is exposed to the solvents in the new coatings. Feathering would not eliminate the problem if curling or lifting resulted from the exposure of a previously applied, solvent sensitive coating to an incompatible solvent. In fact, feathering would increase the problem. Since most of the edges are not indicating a problem with lifting, it appears at this time that the problem likely occurred as a result of the specification not requiring feathering these areas to provide a smooth and gradual transition for the application of subsequent coats.

**Figure 3: Lifting of the previously applied coating along the unfeathered edge**

MANTA repaired the area shown in Figure 3 before the conclusion of the final inspection.

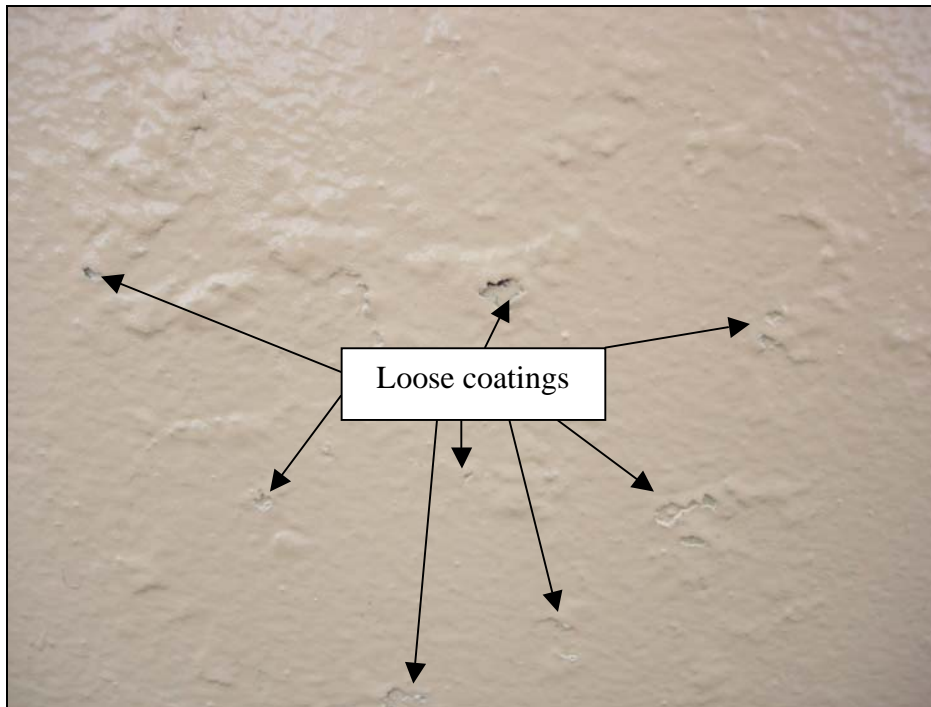
Figure 4 shows several examples of coatings that are not tightly adhered and that were easily removed when subjected to a dull putty knife. The adjoining areas were tightly adhered and were not removed when subjected to a dull putty knife. Normally the surface is subjected to the dull putty knife after it is prepared and before additional coatings are applied; however, in this case, full time inspection was not a part of the scope of work and MARK 10 was not on site to check these areas after MANTA's surface preparation and or repair work was performed on these areas. For this reason the putty knife was used in areas where visible evidence of loose coatings appeared to exist.

**Figure 4: Loose coatings prior to dull putty knife test**

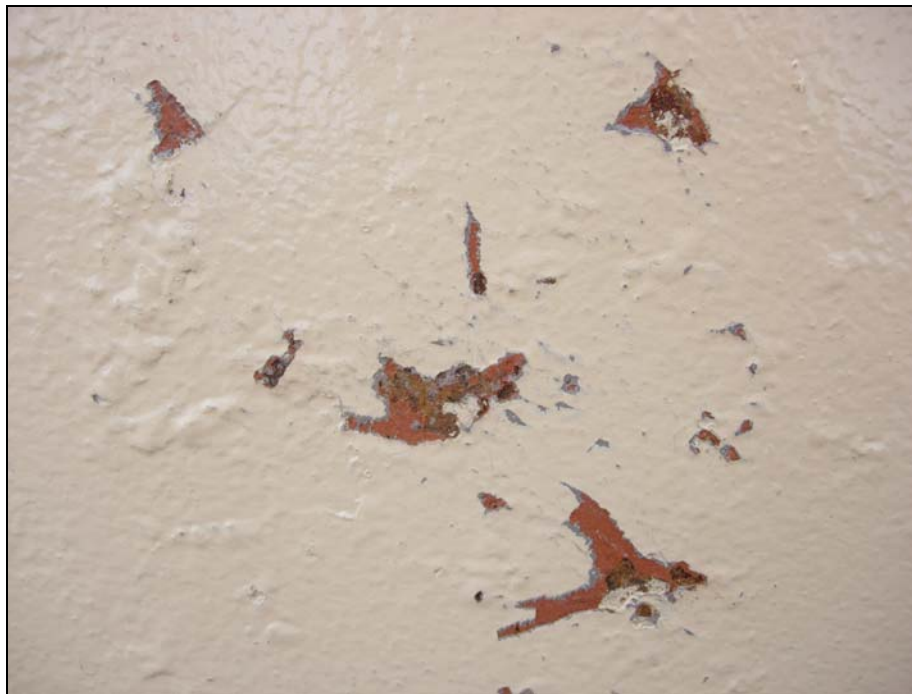
The area shown in Figure 4 (before being subject to the dull putty knife) is shown in Figure 5, after it was subject to the dull putty knife. The putty knife removed at least two and possibly three layers of coating in this area and exposed a previously applied coating.

**Figure 5: Loose coatings removed with dull putty knife**

The area shown in Figure 5 was repaired by MANTA prior to the completion of the final inspection.

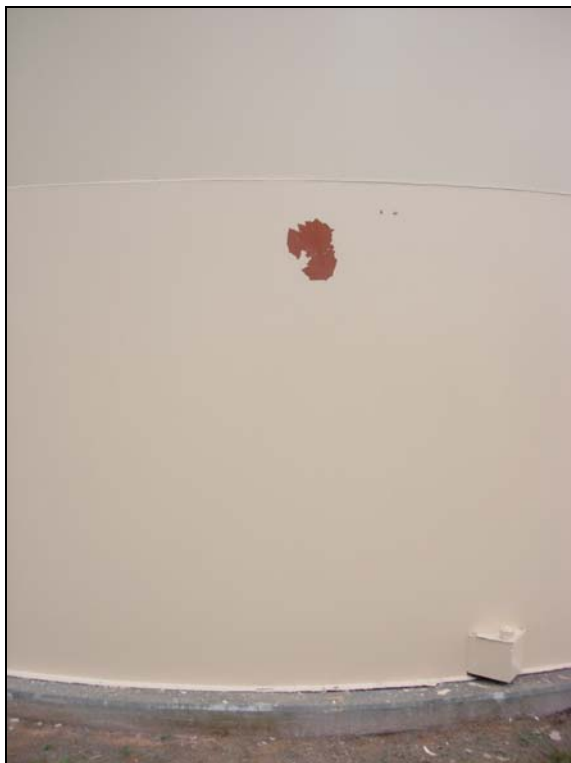
**Figure 6: Long view of delaminating paint**

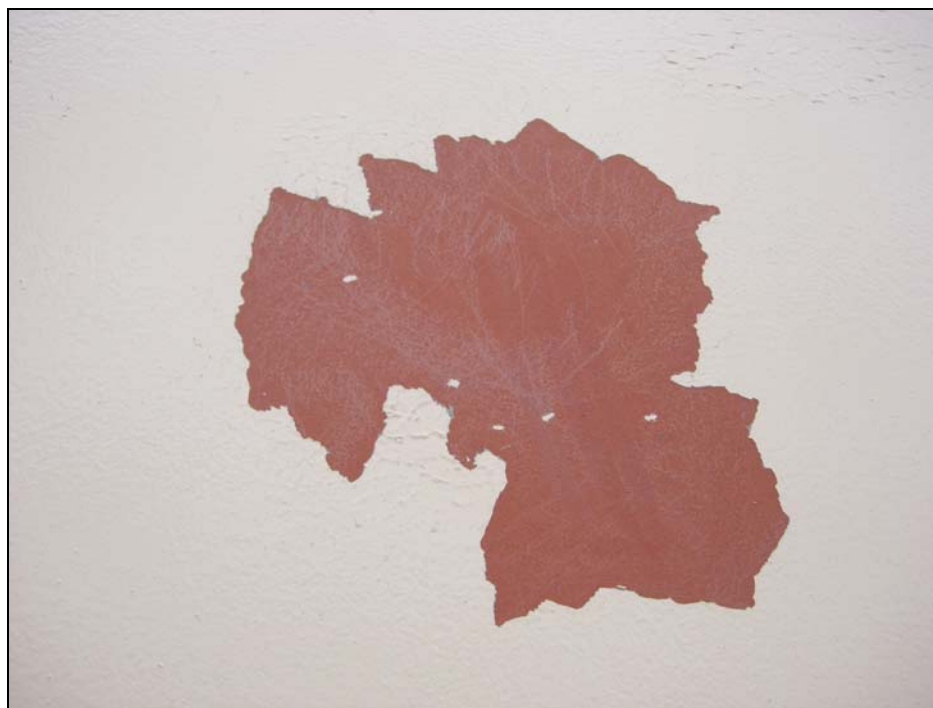
However, it is noteworthy that during the in-progress inspection, the outer surface of the Corothane I Mastic primer that MANTA applied was chalky. Reportedly this coat was applied only two weeks previous to the inspection. MANTA agreed to clean off the chalk before applying the topcoat. Based on

examining the back of the delaminated coating, it appears that the back of the chip contains all or part of the Corothane I Mastic primer and possible another previous coat.

**Figure 7: Close up of area shown in Figure 6**

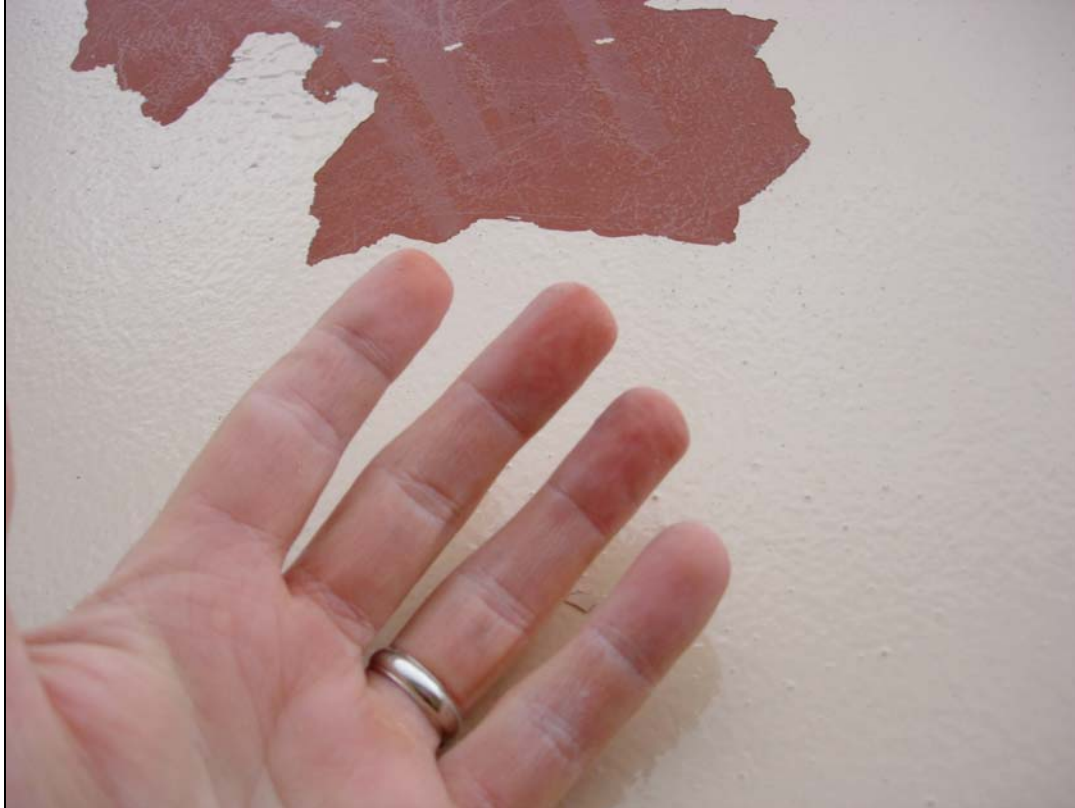
Figure 8 shows red chalky paint on the end of the report author's fingers after they were rubbed across the surface at the top of the picture. Three track marks from where the fingers were moved across the red surface are visible. Chalk is essential dead paint caused by ultraviolet degradation of the binder and or pigments. If coatings are applied on top of a chalky surface, their adhesion will be marginal at best. (Note: The area shown in Figure 8 was cleaned and repaired by MANTA.)

**Figure 8: Chalk seen on fingers after rubbing on coated surface where delamination occurred**

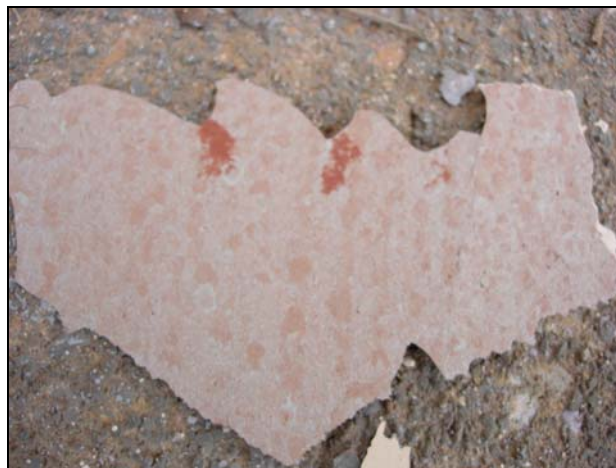
**Figure 9: Backside of coating that delaminated**

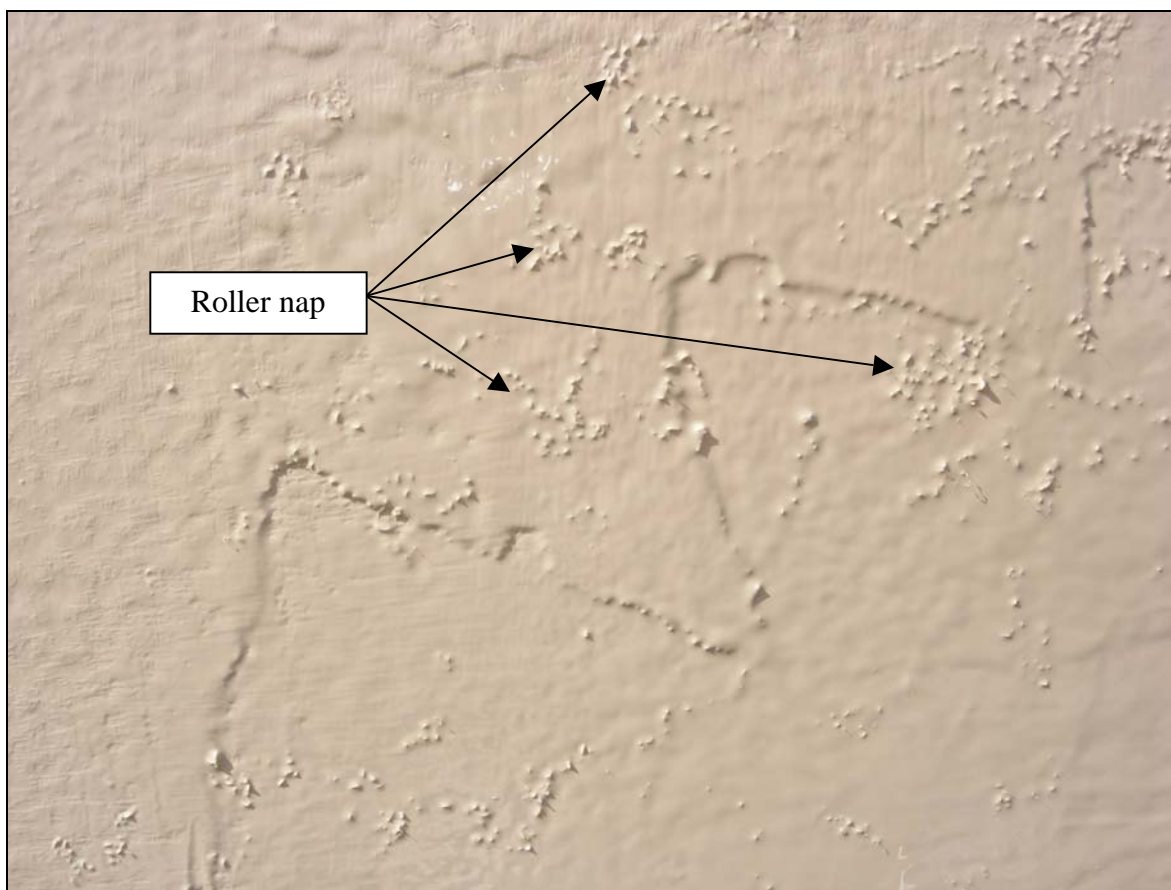
On portions of the tank areas with small pieces of embedded roller nap are visible within the finish coat. MANTA took appropriate measures to prevent this from occurring. They used non-shedding roller covers; however, the roller nap unfortunately shed and it was embedded within the film.

**Figure 10: Small pieces of roller nap embedded within the Corothane I Ironox A finish coat**

In regards to these small pieces of embedded roller nap, (see Figure 10), it would be necessary to remove the topcoat in these area to effectively remove the roller nap entirely. As this would likely cause damage to previous coats, MANTA did not remove the embedded roller nap from within the finish coat on the Destiny Deluge Tank.

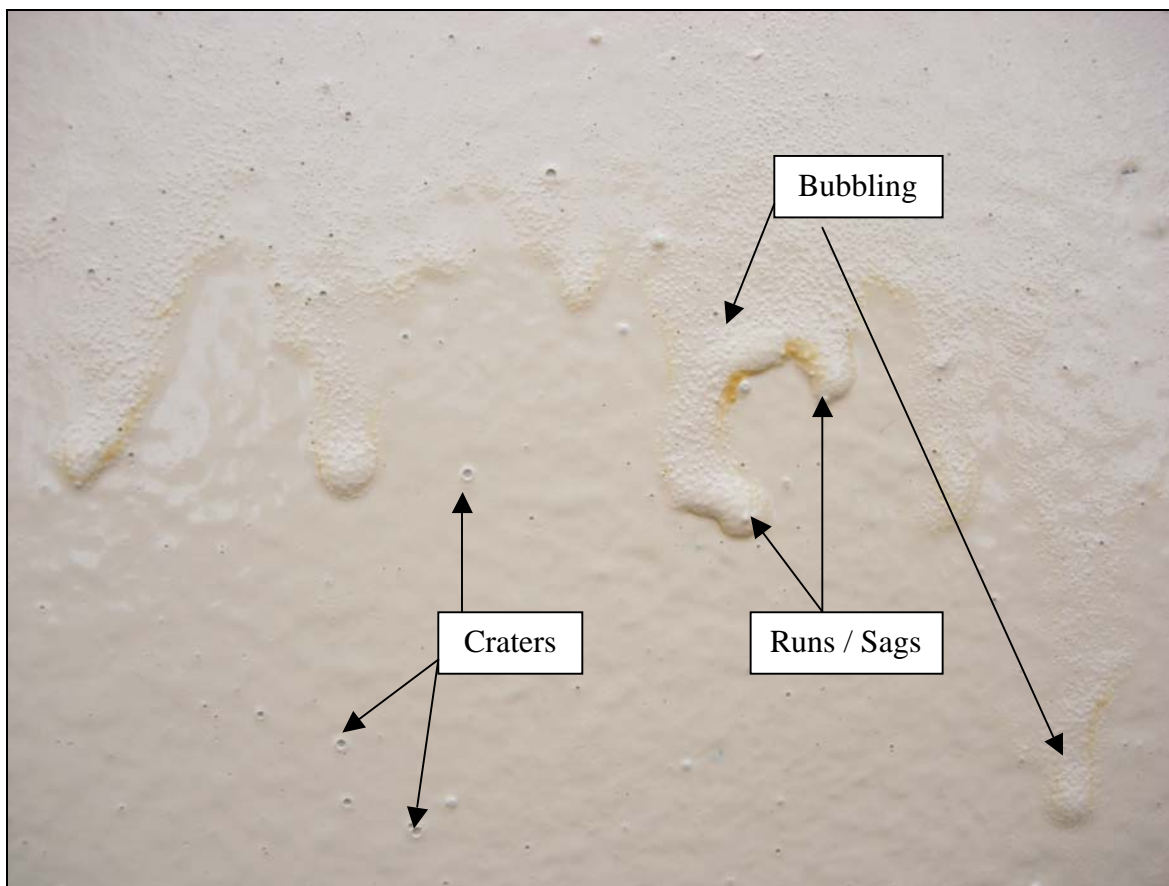
The finish coat film appeared to bubble and form pinholes and craters in some cases after it was applied. This appeared to be occurring in areas where the SW Corothane I Ironox A finish coat was applied at excessively high dry film thicknesses. Overall the dry film thickness on the tank is within the manufacturers recommended dft; however, there are isolated areas where the dft exceeds the recommended dft. Figure 12 shows an example of bubbling, craters, small pinholes and several runs / sags.

**Figure 12: Foaming, craters, runs and sags in finish coat on Sabre Deluge Tank**

The runs and sags seen in Figure 12 are located in the finish coat. They are not telegraphing through from a previous coat. Over time the excessive thickness in these areas may result in local premature coating failure (e.g. cracking or delamination) due to internal stress as the coating is exposed to the thermal contraction and expansion of the tank.

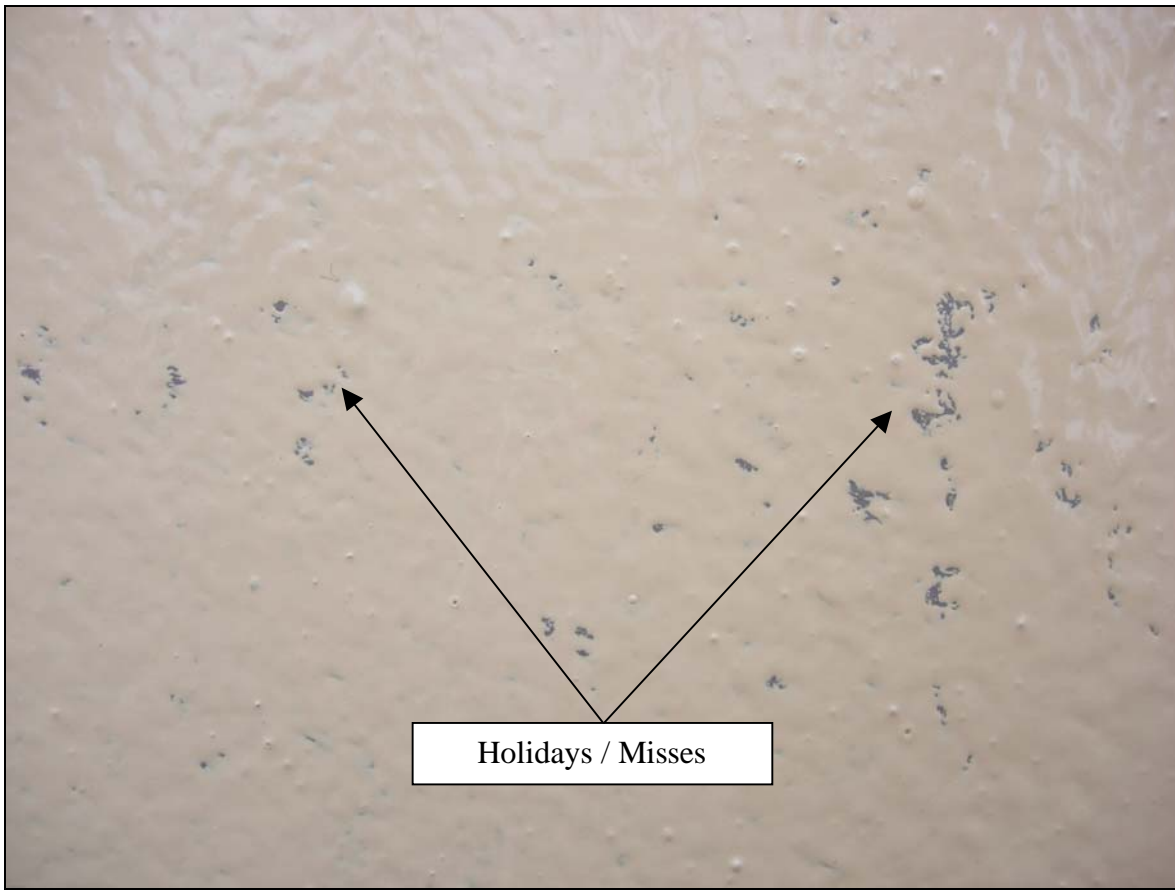
During the final inspection a few holidays in the topcoat were observed in an area adjacent to the ladder. These holidays are located between the Sherwin Williams Corothane I Ironox A topcoat and the Sherwin Williams Corothane I Mastic primer (see Figure 13).

**Figure 13: Holidays / missed areas in the Sherwin Williams Corothane I Ironox finish coat**

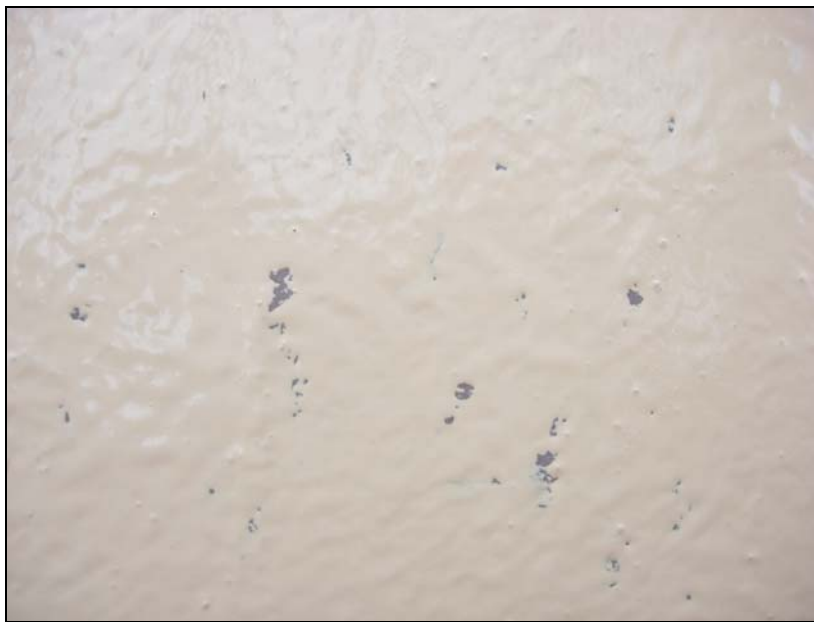
**Figure 14: Holidays / misses**

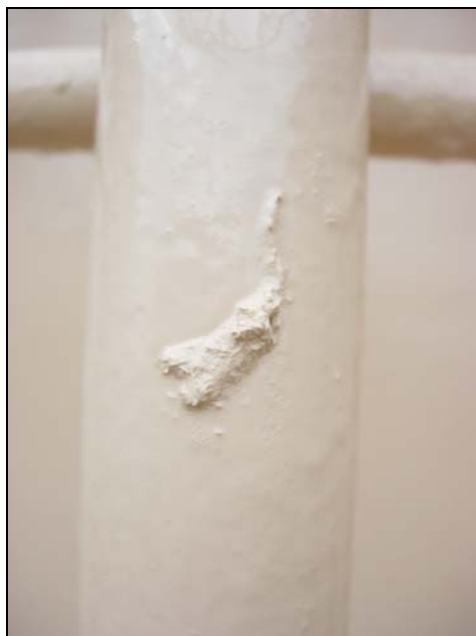
A large section of roller nap was embedded in the finish coat in a few areas of the tank ladder assembly. The roller nap was cut out of the film leaving an area with crater-like pores in the film. (See Figure 16 and Figure 15.)

**Figure 16: Roller nap in paint film**

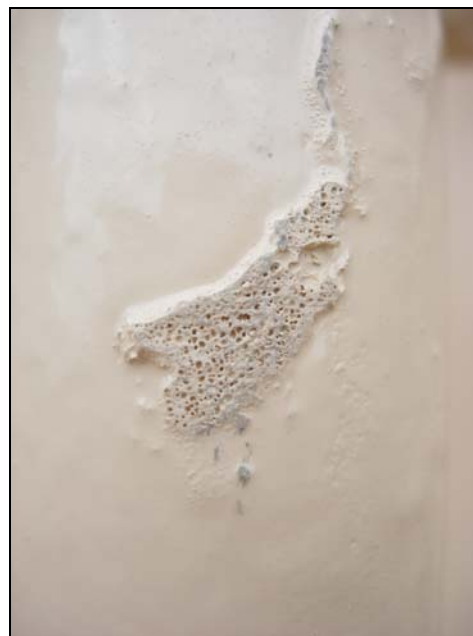
**Figure 15: Roller nap removed**

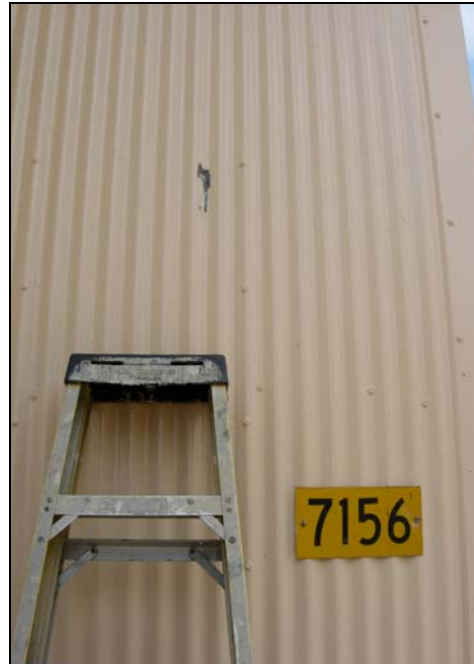
**Figure 24: Long view after removal**

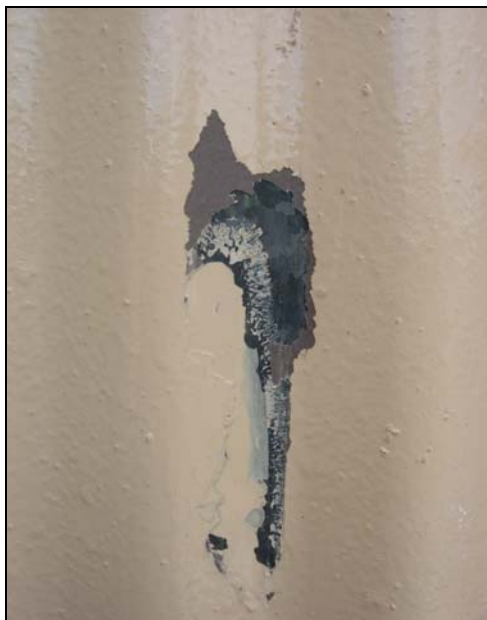
**Figure 26: Close-up of area after removal**

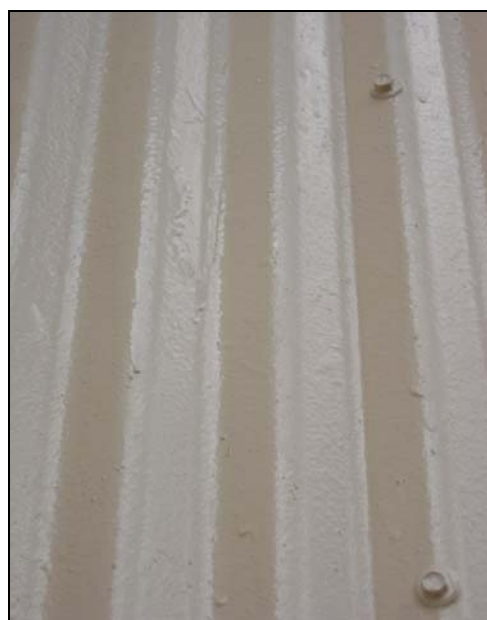
**Figure 25: Close-up after repair**

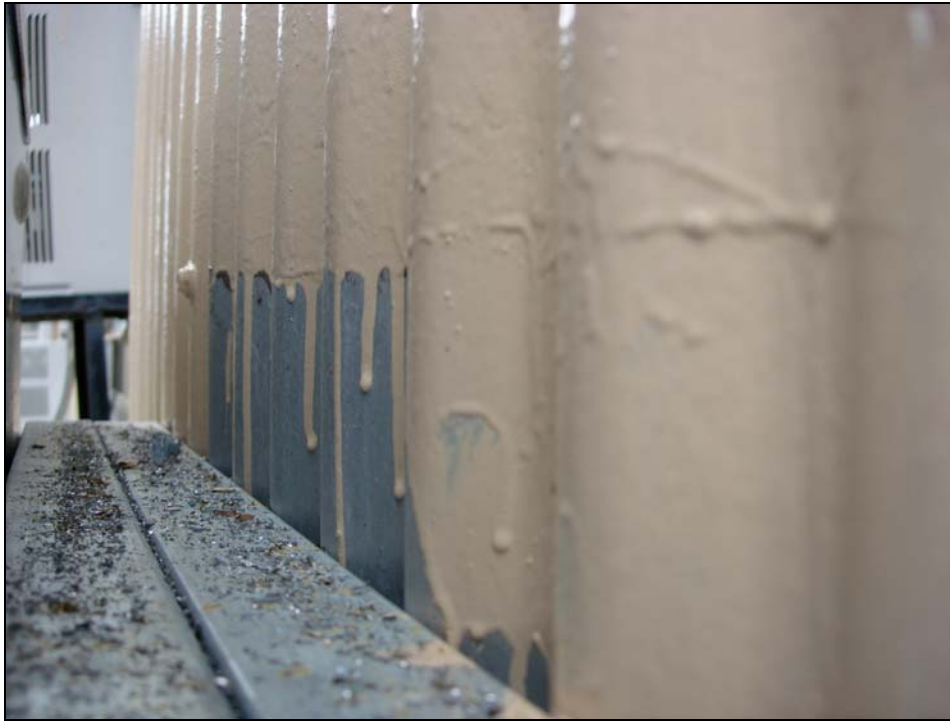
As mentioned in the In-Progress Inspection Report, signs affixed to the building were painted around, leaving the areas beneath them unpainted. In some cases, the signs were riveted to the building, making it impractical to remove them. In another area, the siding near some electrical conduit pipes close to the building was very difficult to access and was not primed or topcoated. The previously applied aluminum coating is visible (Figure 27).

**Figure 27: Difficult to access area that was not primed or topcoated**

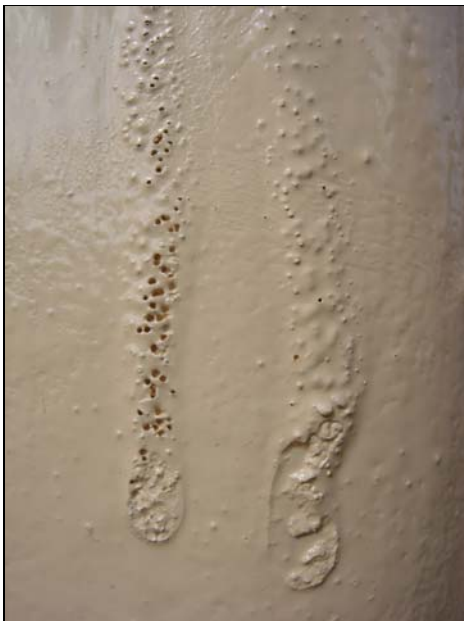
**Figure 28: Two cut off coating “runs”**

Cutting off the excess coating material leveled one of the runs, identified during the in-progress inspection; however, it was not adequately recoated, resulting in crater-like pores in the film.

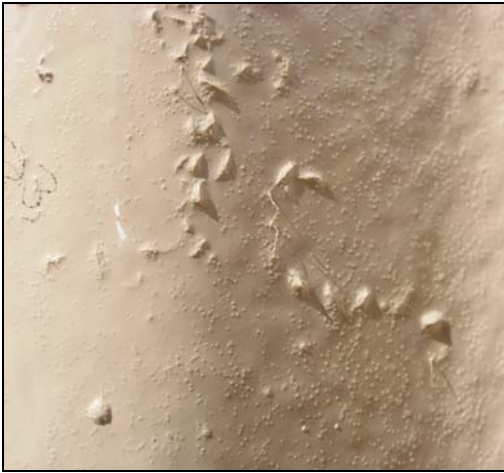
Roller nap and brush hairs were observed in several locations on Hangar #2. They were embedded within the topcoat film.

**Figure 29: Roller nap in topcoat film**

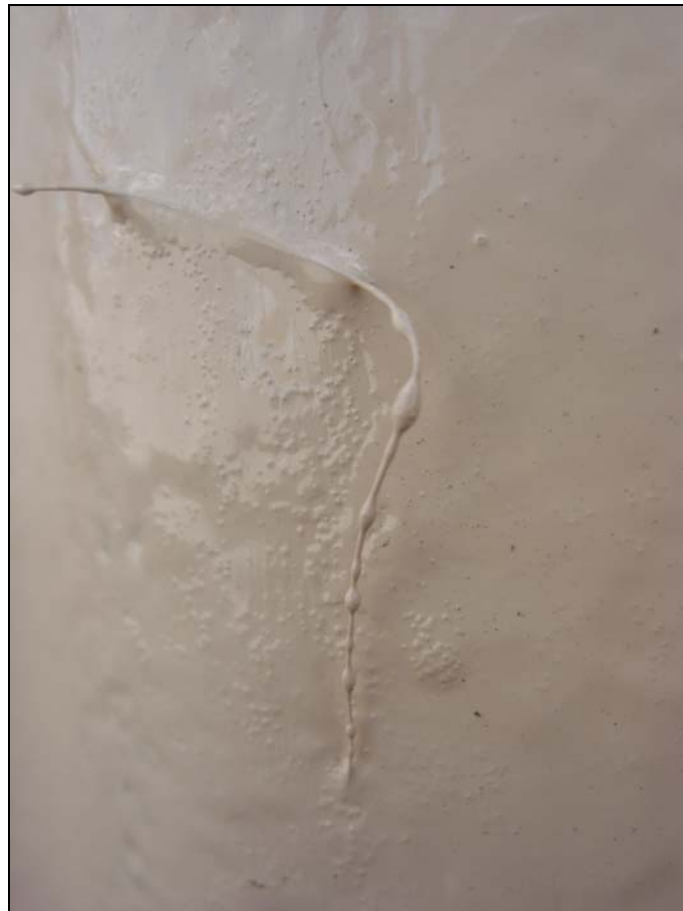
**Figure 31: Brush hair in topcoat film**

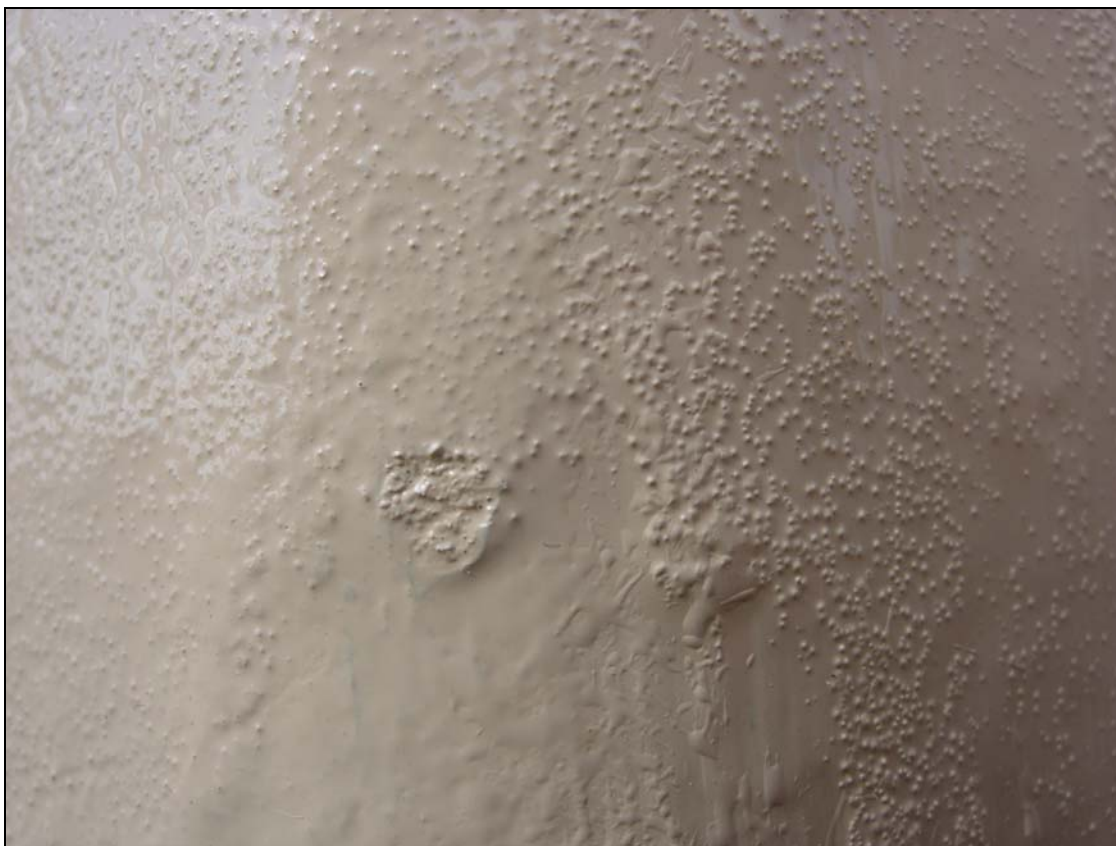
Several areas on Hangar #2 were observed that exhibited a bubbling appearance in the film. The inside of these bubbles are hollow, similar to those shown earlier in this report (see Figure 28). This was also observed in some areas on the Sabre Deluge Tank, generally in areas with higher dry film thickness. Bubbling in moisture-cured urethanes is sometimes caused by rapid CO<sub>2</sub> generation when the coatings are applied in high humidity conditions and at higher dry film thicknesses.

**Figure 32: Small bubbles in the Sherwin Williams Corothane I Ironox topcoat**

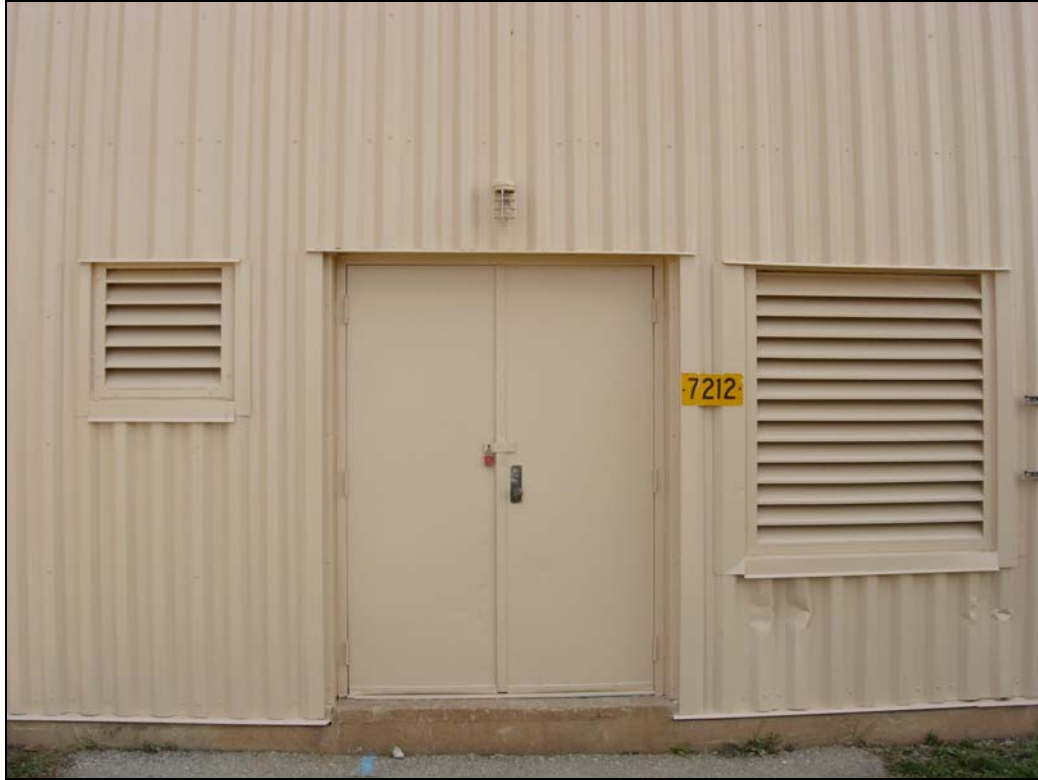
These missing and/or damaged corner siding pieces and the dented siding represent pre-existent conditions that were present before MANTA began work on this structure and were noted in the In-Progress Inspection Report.

**Figure 34: Dented siding on Flight Control Tower beneath the large vent**

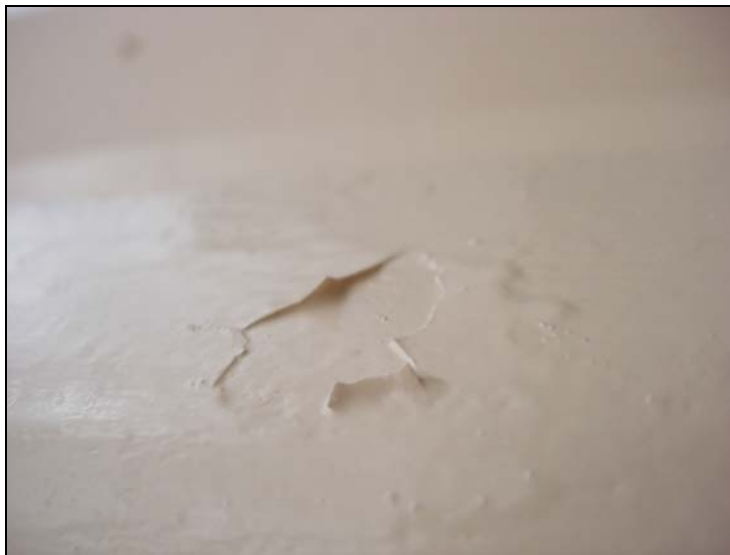
**Figure 35: Edges of coating are not adhered to the surface**

Figure 35 shows a side view of a raised up area of the coating in an isolated area on the Flight Control Tower. The coating in this area does not conform to the requirements of SSPC SP 3, since it is easily removed when subject to a dull putty knife.

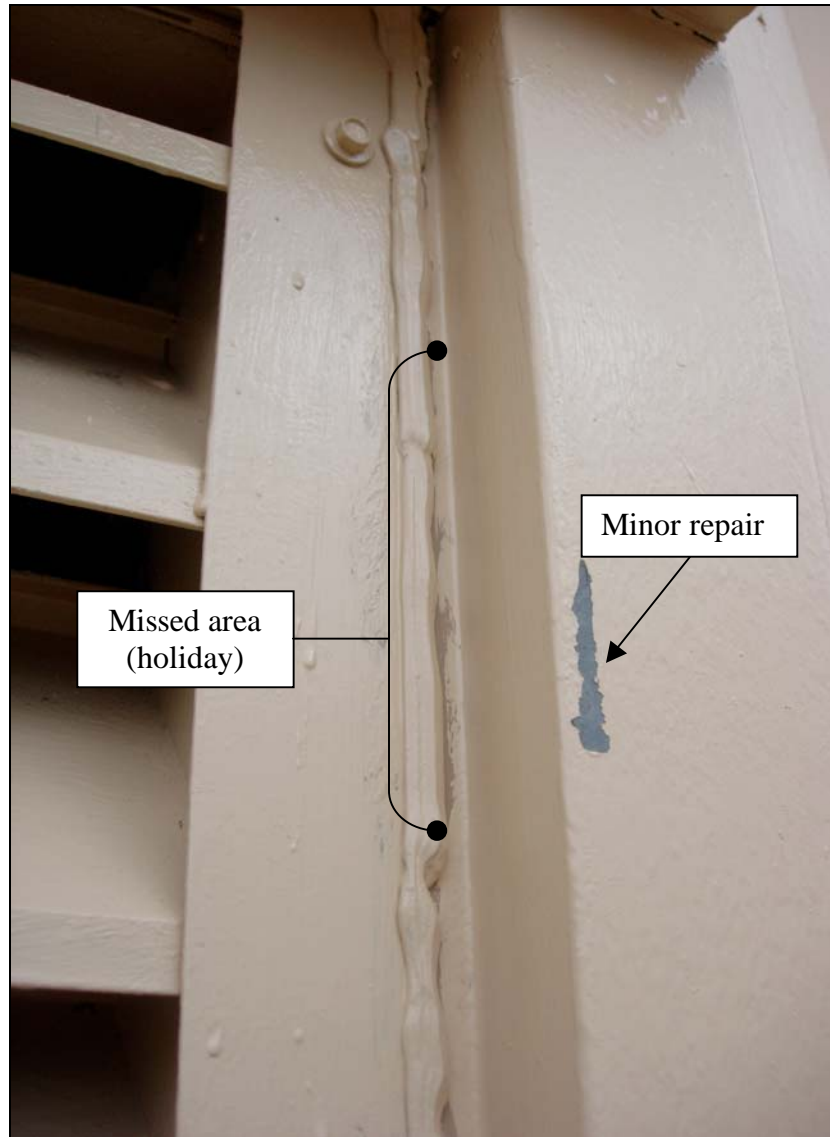
**Figure 36: Area with holiday missed area and minor repair**

In Figure 36, the back of the Flight Control Tower shows a holiday area running vertically along the caulk seam and a minor delamination requiring touch-up. These isolated problems are minor cosmetic issues and do not characterize the structure. Overall the paint applied on the Flight Control Tower appears to be in very good condition.

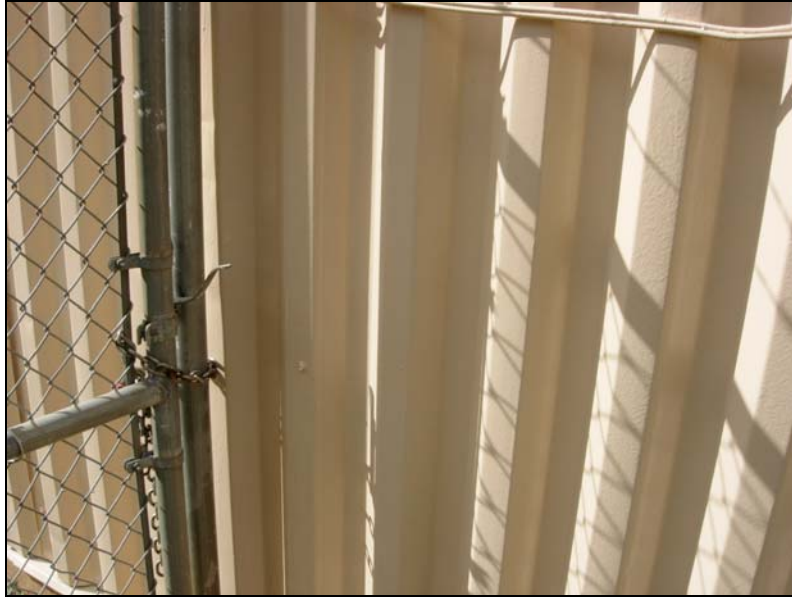
The coating in one area near the gate was damaged in two spots. This appears to be due to some type of mechanical damage, possibly related to the gate-latch device. MANTA touched up these damaged spots during the final inspection. If the gate-latch device caused the coating damage, it is likely to reoccur in this area unless it is corrected.

**Figure 37: Close-up of the gate and latching device**

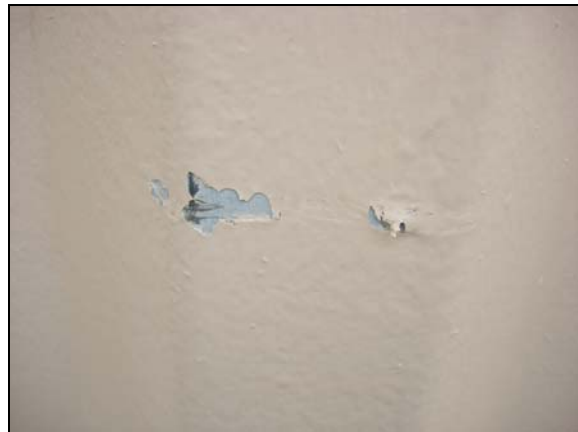
**Figure 39: Damage to paint from gate latch**

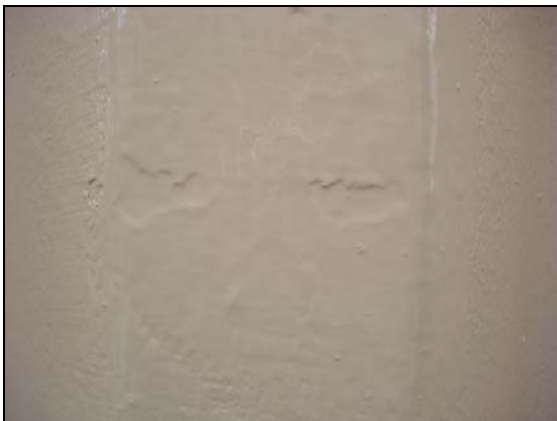
**Figure 40: Area after MANTA repaired damage**

The series of pictures on this page shows the paint damage on the lower portion of the Flight Control Tower that was repaired by MANTA during the final inspection.
